## SERVICE BULLETIN

**Beech**

**TITLE: WINGS - INSPECTION OF WING SPAR STRUCTURE**

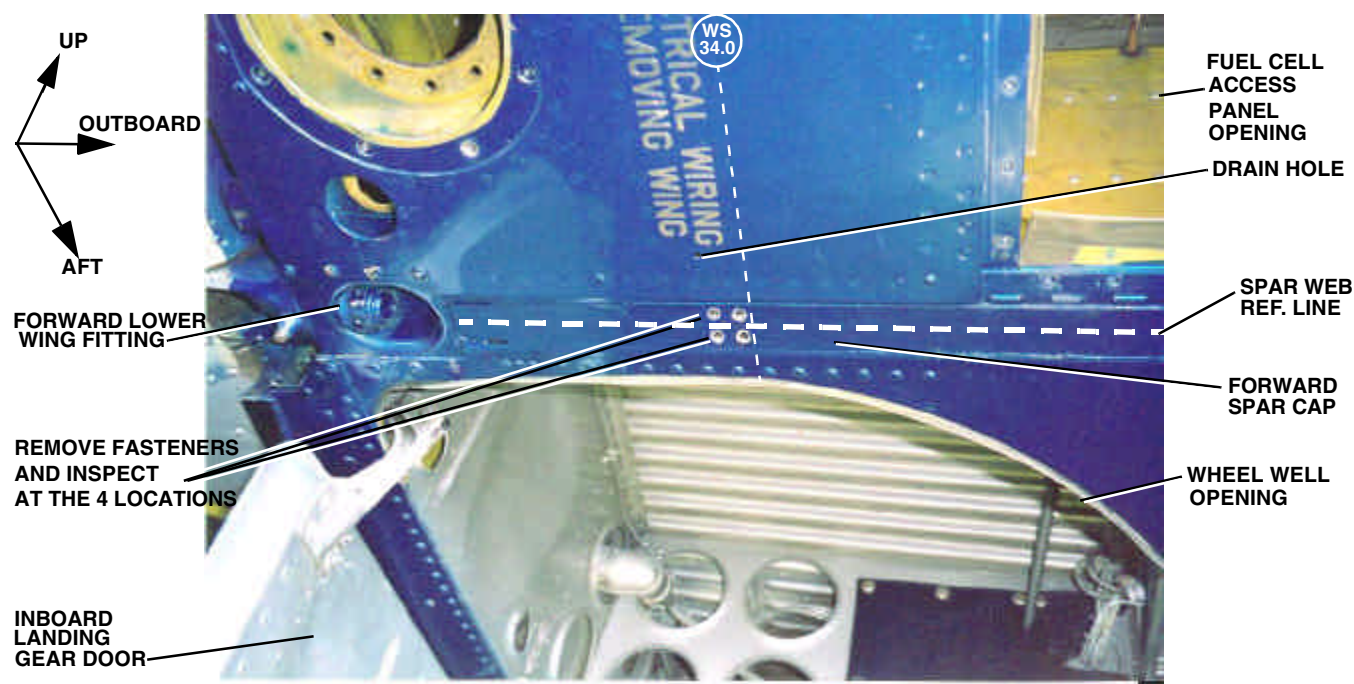
**Inboard Forward Spar Inspection (Lower Side)**  
Figure 5

- (ii) Ream the group of four (4) fastener holes in the forward spar lower hinge extrusion (spar cap) (reference Figures 5 and 6) that were removed in step (8) (b) (ii), to the first oversize of .2026/.2036 inch diameter for NAS1703 bolts. Protect both the forward and aft side of the forward spar by placing (.005" or .010" thick) brass or stainless steel shim stock sheet against the forward and aft reinforcements before reaming. If a smoother hole is required, it is permissible to ream to the second standard oversize of .2183/.2193 inch diameter for NAS1603 bolts.
- (d) Perform an Eddy Current NDI inspection of each of the 9 fastener holes in the inboard area of the forward spar that were removed in step (8) (b) as follows:

- (f) If a crack is found during the Eddy Current Inspection of the forward spar as outlined in step (d) and step (e), the entire forward (main) spar assembly must be replaced **BEFORE FURTHER FLIGHT**.
- (9) Inspect three (3) MLG trunnion fitting fastener locations as follows:
- (a) Locate the MLG trunnion fittings in the wheel well area, reference Figures 3, 13, 14 and 15. The forward trunnion fitting is attached to the aft side of the forward (main) spar and the aft trunnion fitting is attached to the forward side of the aft (rear) spar near W.S. 63.0.

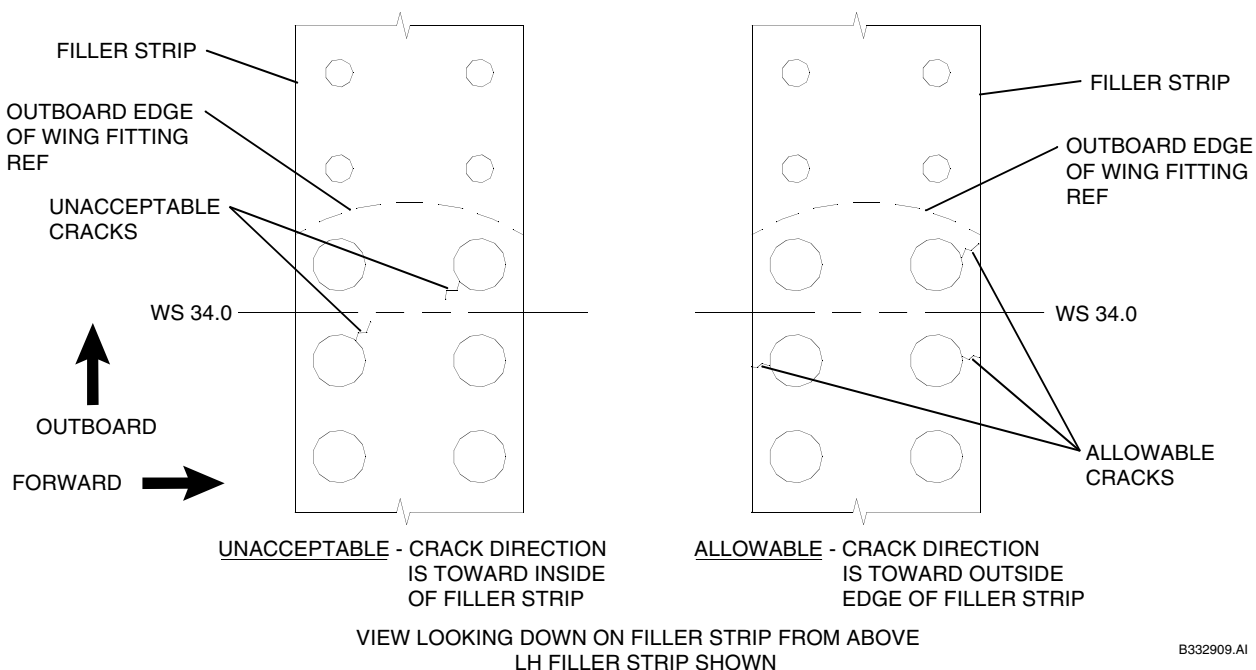
**Filler Strip Cracks  
Figure 10**

A crack indication in the filler strip may be allowed, but only if the direction of the crack indication is toward the outside edge of the filler strip. If the direction of the crack indication is toward the inside of the filler strip, the spar assembly must be replaced. Reference Figure 10.

**A crack indication in the filler strip may be allowed, but only if the direction of the crack indication is toward the outside edge of the filler strip. If the direction of the crack indication is toward the inside of the filler strip, the spar assembly must be replaced. Reference Figure 10.**

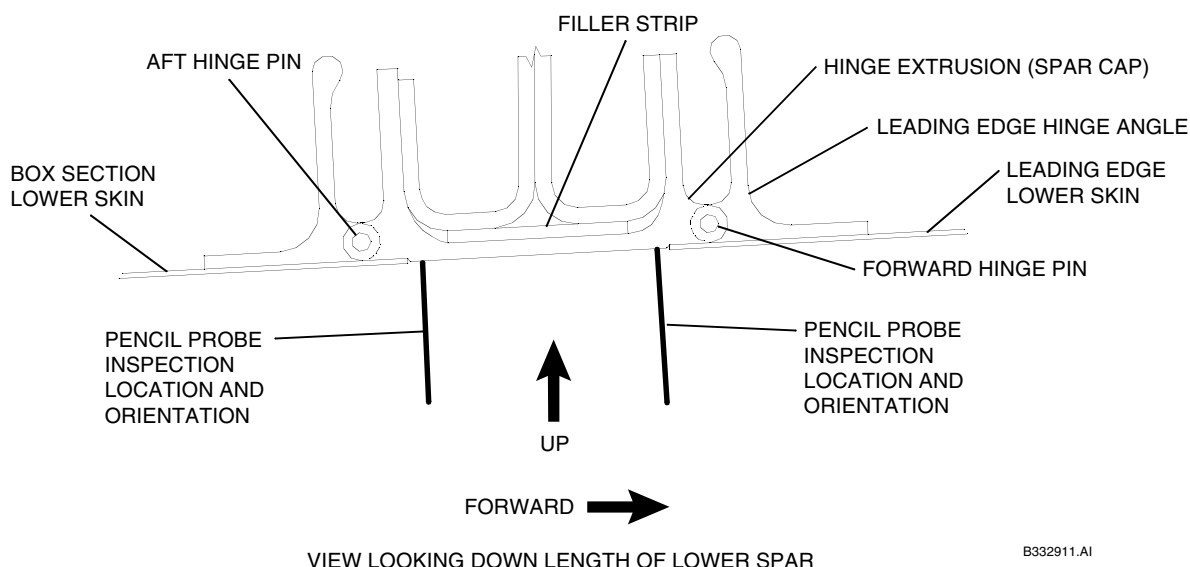
**Eddy Current Inspection of Forward Spar (Lower Surface)**  
**Figure 12**

- Instrument: Same as used to inspect the inboard area of the forward wing spar in step (8) (d).
  - Shielded Eddy Current pencil probe, minimum 100 kHz, absolute coil.
  - Aluminum Electron Discharge Machining (EDM) notch standard as shown in Figure 9.
- (i) Adjust the instrument using the .030" EDM notch on the flat of the standard. Obtain a minimum 50% screen deflection.
- (ii) On the lower surface of the forward spar from the attach fitting outboard to the end of the exposed spar (wingtip), scan the exposed surface of the forward and aft edges of the hinge extrusion adjacent to the hinge attach point with the pencil probe as shown in Figure 12.

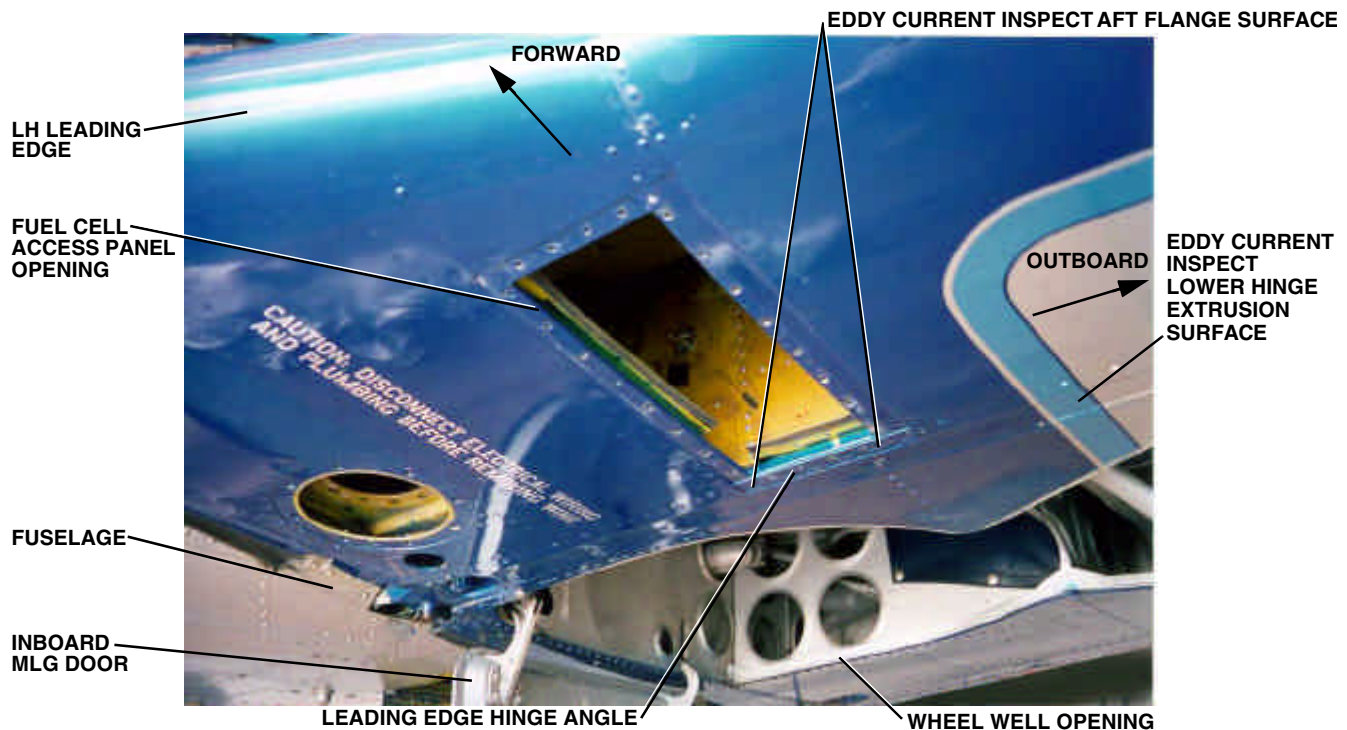
VIEW LOOKING UP AND AFT AT THE LOWER SURFACE OF THE LH WING  
Leading Edge Hinge Angle and Fuel Cell Access Panel  
Figure 17

- (v) Note any crack indications.
- (f) Perform an Eddy Current NDI inspection of two (2) of the leading edge hinge angle surfaces. The first area to be scanned is located on the leading edge lower hinge angle adjacent to the small square access panel opening (fuel vent access door/trunnion access door) near the MLG trunnion, reference the aft flange in Figure 14. The second area to be scanned is adjacent to the aft side of the fuel cell access panel opening (reference aft flange surface in Figure 17).

- (v) Visually inspect the lower wing skin adjacent to the area Eddy Current Inspected in step (10) (f) (iv). Look closely at the area next to the fuel cell access panel aft flange surface for cracks or distortions in the paint. Reference Figure 17. If distortions are found, remove the paint for a closer inspection. Visually check for cracks in the lower wing skin and leading edge lower hinge angle.

- (g) If a crack is found during the Eddy Current Inspection in any of the fastener holes inspected in either step (10) (d), the hinge radius inspected in step (10) (e) or the lower skin and hinge angle surface inspections in step (10) (f) the corresponding hinge angle assembly(ies) must be replaced **BEFORE FURTHER FLIGHT**.

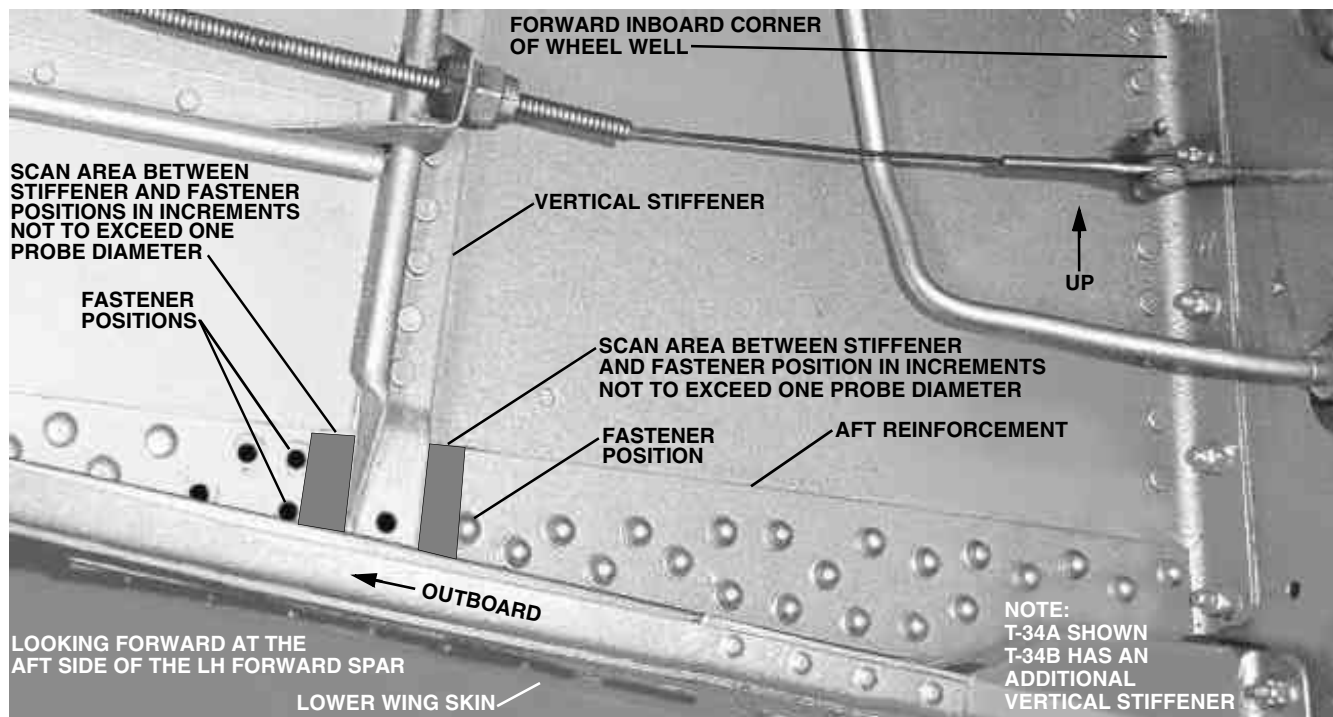
**Figure 28**

**Aft Reinforcement Surface Inspection**

- (g) If a crack is found during Eddy Current Inspection of the aft reinforcement, the entire forward (main) spar assembly must be replaced **BEFORE FURTHER FLIGHT**.
- (13) Inspect the upper and lower spar caps and adjacent hinge angles for corrosion in accordance with the steps outlined in Mandatory Service Bulletin No. 2538, Rev. I., attached to this Service Bulletin. Also inspect for corrosion on the forward side of the forward spar from inside the leading edge fuel cell cavity, and on the aft side of the forward spar from inside the wheel well. Inspect the forward side of the aft spar from inside the wheel well.
