## SERVICE BULLETIN

**Beech**

**TITLE: WINGS - INSPECTION OF WING SPAR STRUCTURE**

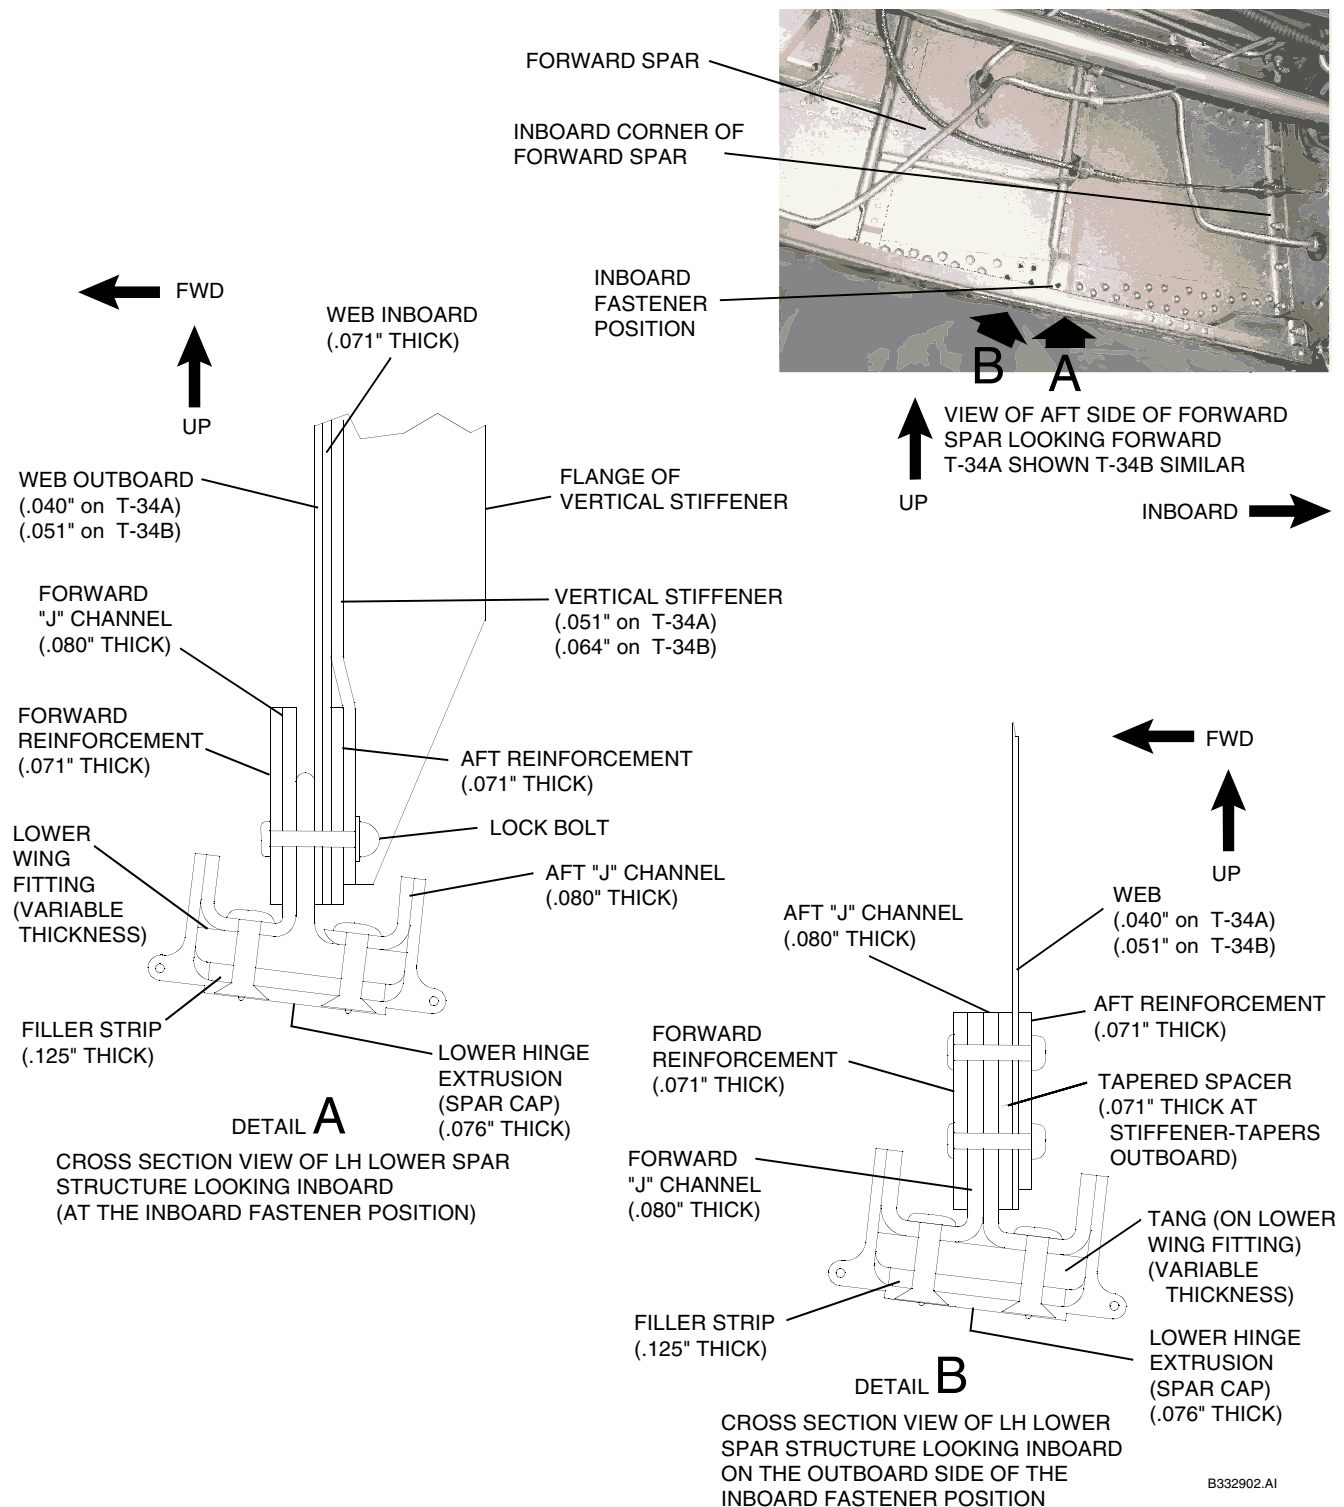
The lower inboard section of the forward (main) spar is constructed of several layers of sheet metal and metal extrusions which are formed, fitted and attached to the lower wing fitting. As viewed from the inboard side looking outboard, the cross section of the lower forward spar is shaped similar to an upside down "T" (reference Figure 2) with multiple layers reinforcing the upside-down "T".

**Typical Spar Cross Section  
Figure 2**

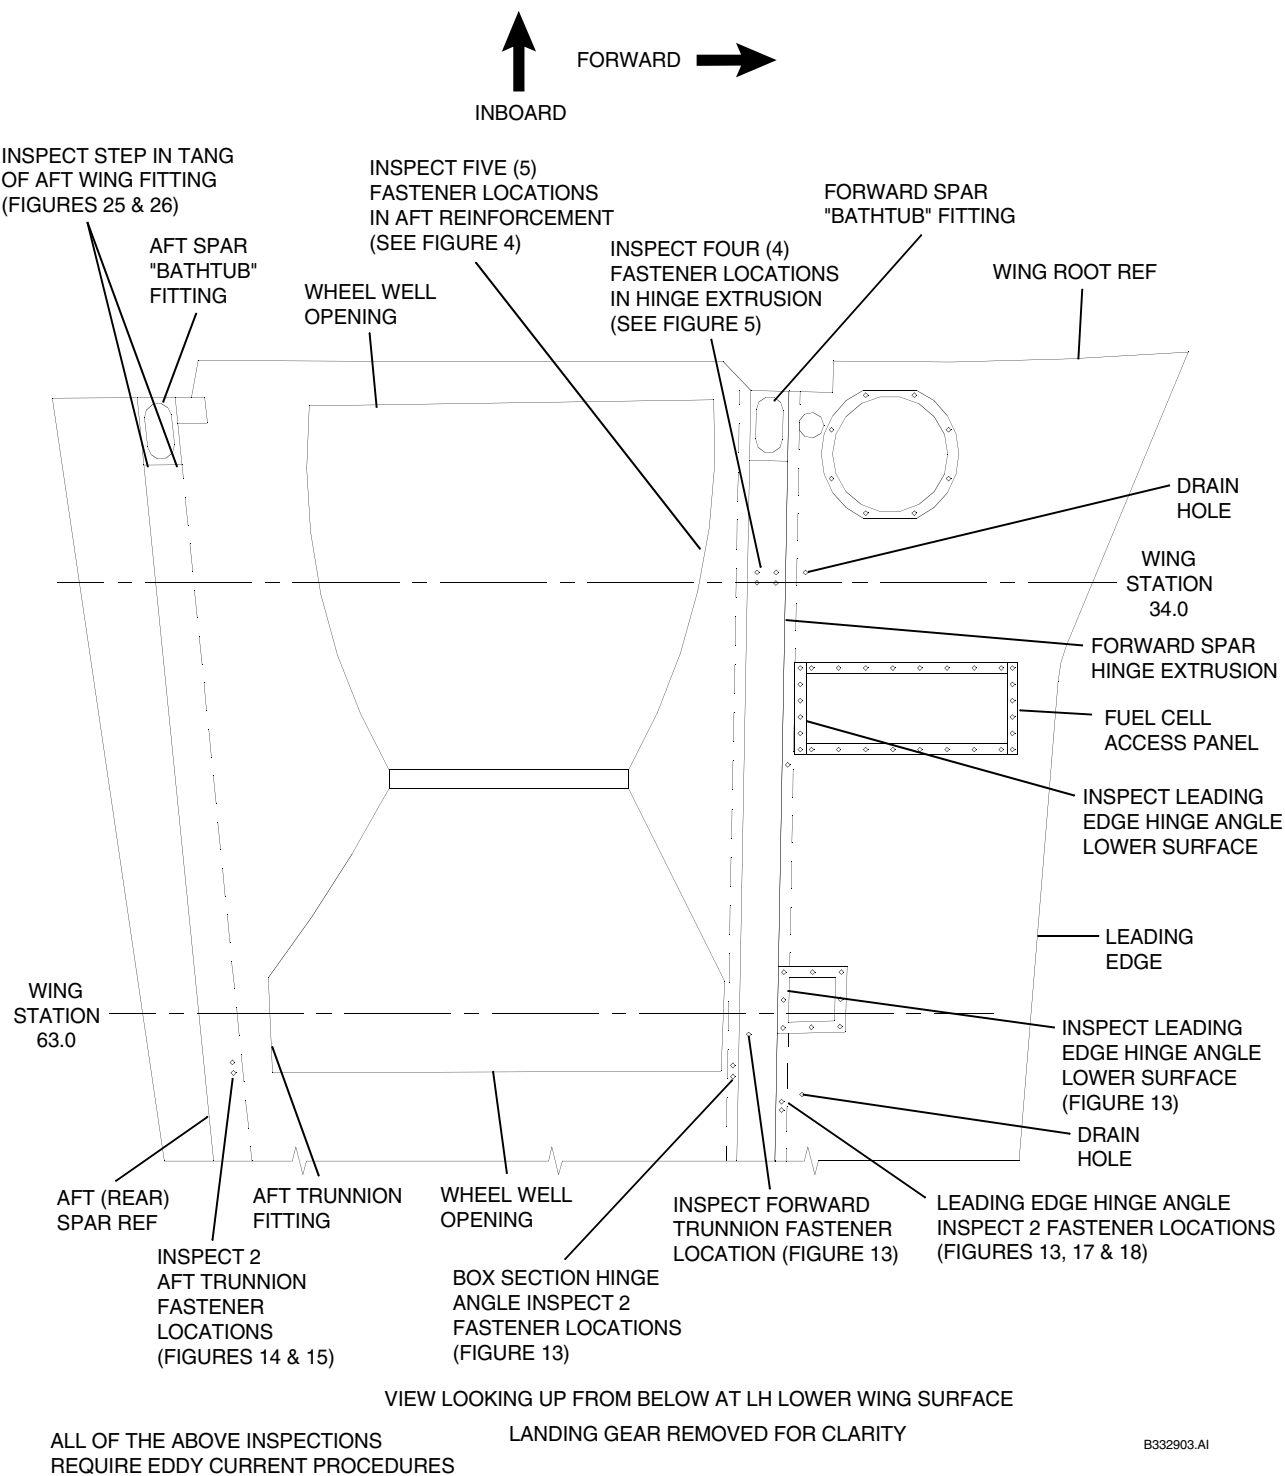
Figure 3

- (a) Locate the inboard forward (main) spar inspection area near W.S. 34.0 as shown in Figures 3, 4 5 and 6. This area consists of nine (9) fasteners in the lower forward spar.

Inspection Locations (LH Wing Shown)

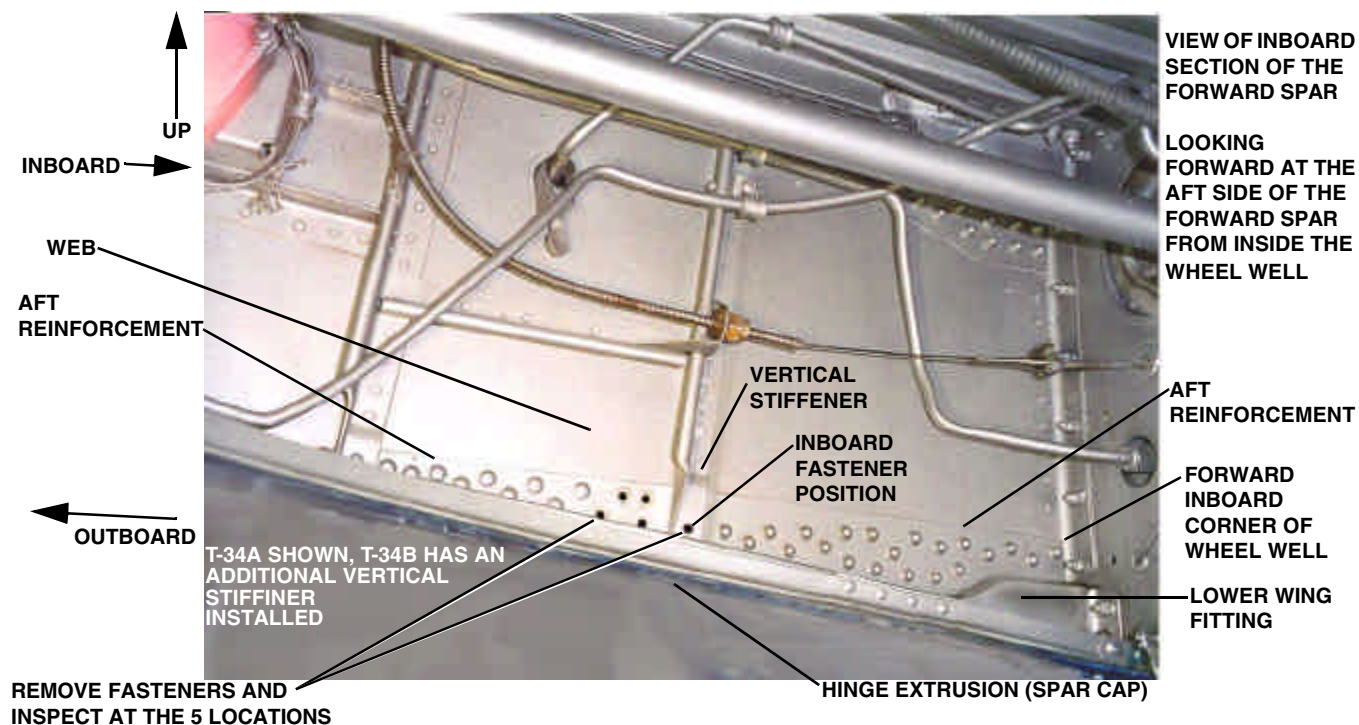
- Of the five (5) fasteners, the inboard fastener (reference the inboard fastener position in Figure 4) is installed in the vertical stiffener, aft reinforcement, spar web (both forward and aft elements), vertical spline of the lower forward wing fitting, forward "J" channel and forward reinforcement. Reference Detail A in Figure 2.
- The other fasteners in the group of five (5) are installed in the aft reinforcement, spar web, tapered spacer, aft "J" channel, forward "J" channel and forward reinforcement. Reference Figure 4 and Detail B in Figure 2.

**Inboard Forward Spar Inspection (Aft Side)**  
Figure 4

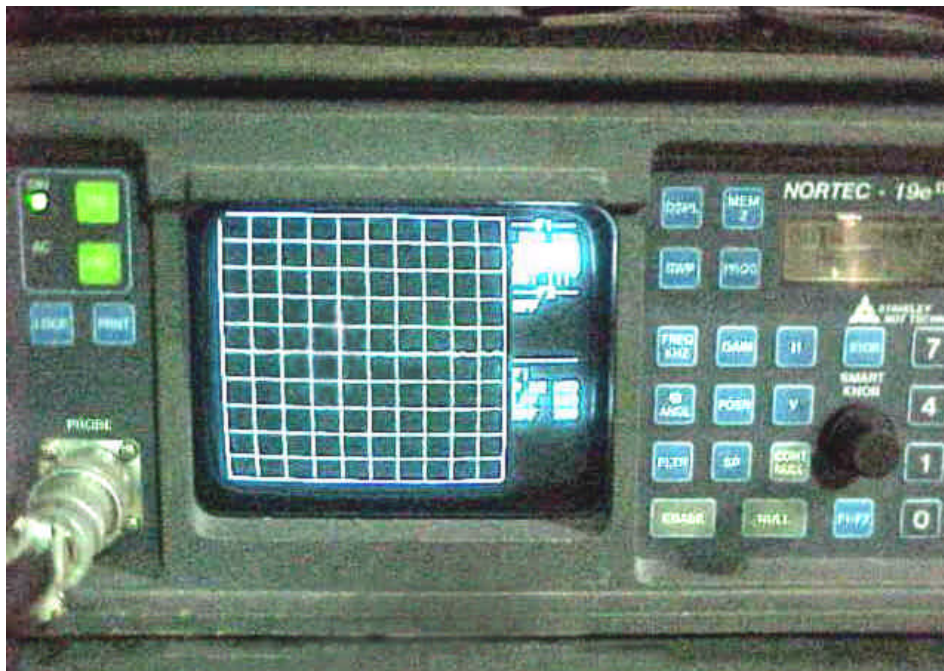
**Figure 8**

**Impedance Plane Eddy Current Instrument - Nortec Staveley 19e**

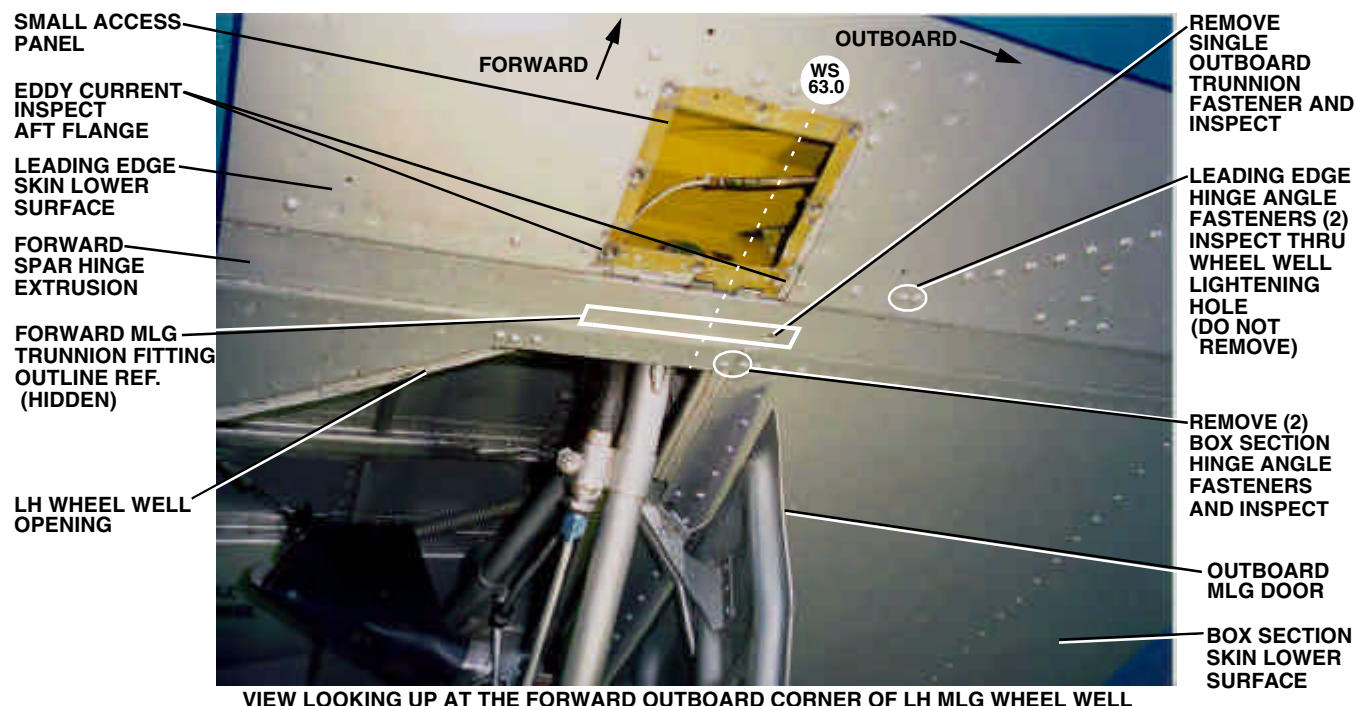
Forward Trunnion and Hinge Angle Fastener Locations (LH side shown)  
Figure 14

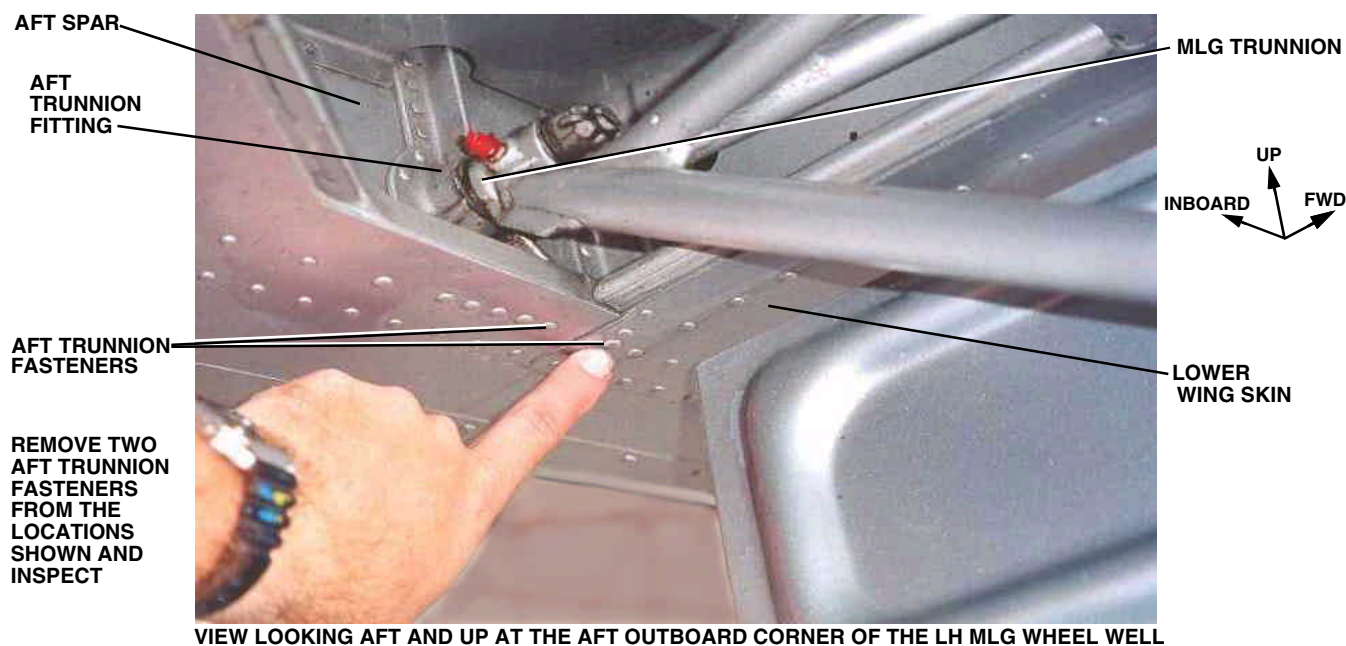
Identify the two (2) outboard fasteners in the lower flange of the aft MLG trunnion fitting. The two aft trunnion fasteners are installed in the aft spar lower element (capstrip), forward "L" angle horizontal flange ("L" angle of the aft spar) and lower flange of the MLG trunnion fitting. These two (2) fasteners are located in the fastener positions which are closest to the outboard end of the lower flange on the aft MLG trunnion fitting. Reference Figure 15 and Figure 16.

Aft Trunnion Fastener Location (LH Side Shown Before Removal)  
Figure 15

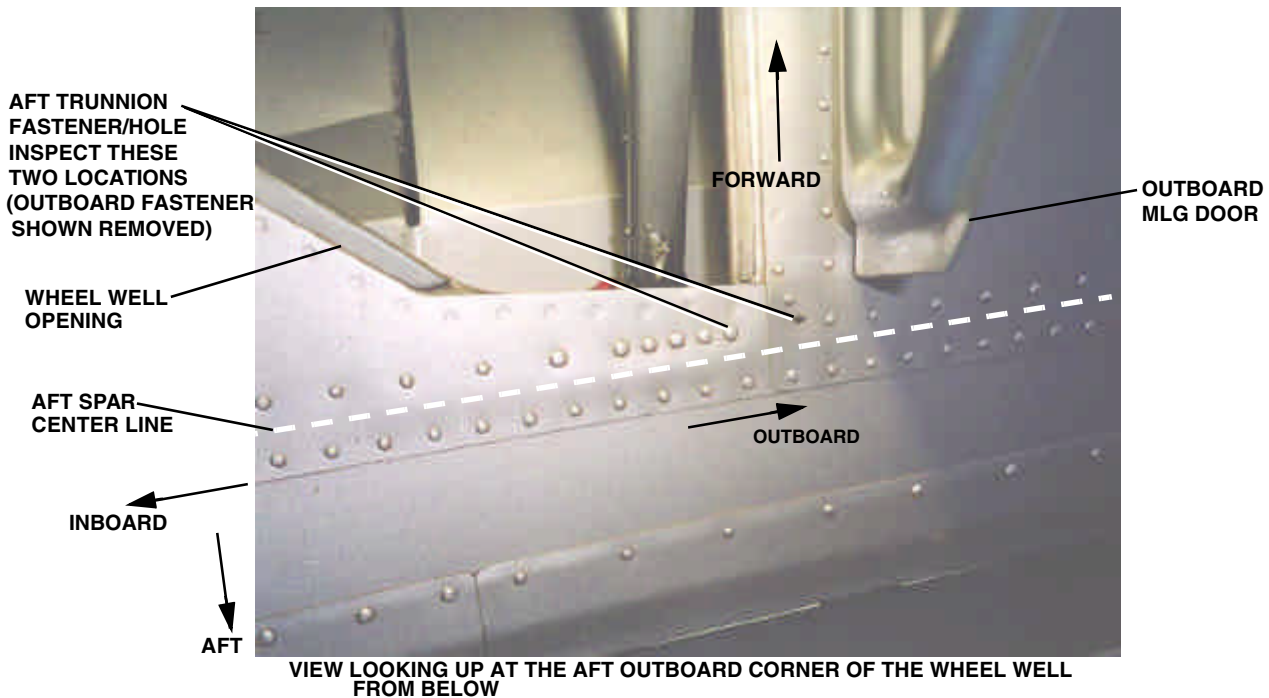
Aft Trunnion Fastener Location (LH Side Shown During Removal)  
Figure 16
